**Washington State Ferry Terminal
Structural Inspection**

Seattle Ferry Terminal

Location	Bridge No.	Type	Inspection Date	Report Received
Slip 3	519/100FT	Routine, FC, Special	6/23/2020	9/23/2020

BRIDGE INSPECTION REPORT

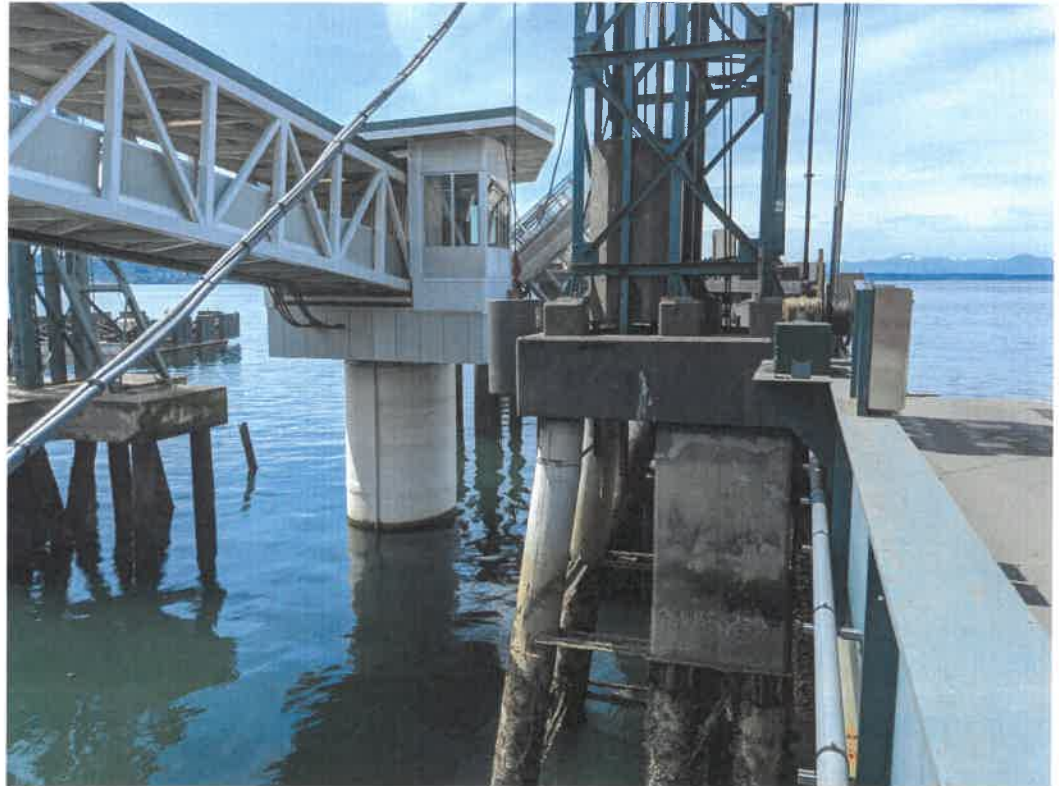
Tower H-piles are concrete encased from the cap down.
The inboard pile sets of 3 piles are encased in a common tapered shroud that looks like a pier wall for the top 12 ft. (Photo #142). The right concrete encased Pile RT3-A1 has section loss of the flanges; the offshore measures 5/16" and the onshore measures 7/16" (Photo #75). It also has large cracks open up to 3/16" by 27" long (Photo #134).
There is visible section loss, laminar rust, in the webs and flanges of all the piles, where they are exposed below the tower base platform (16 piles in CS3).

Concrete encasement of Tower Steel H-piling. Lower part of piles have separate round encasements.

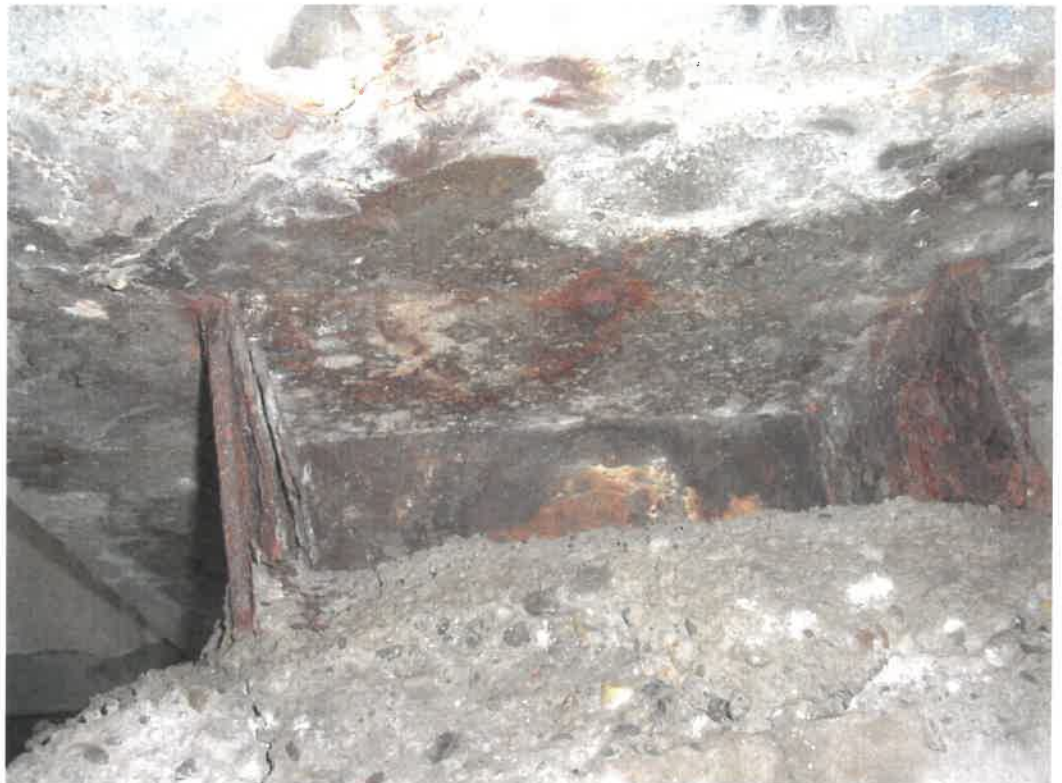
SI-75

Heavy corrosion, laminar rust, of concrete encased Pile RT3-A1. Others are similar.

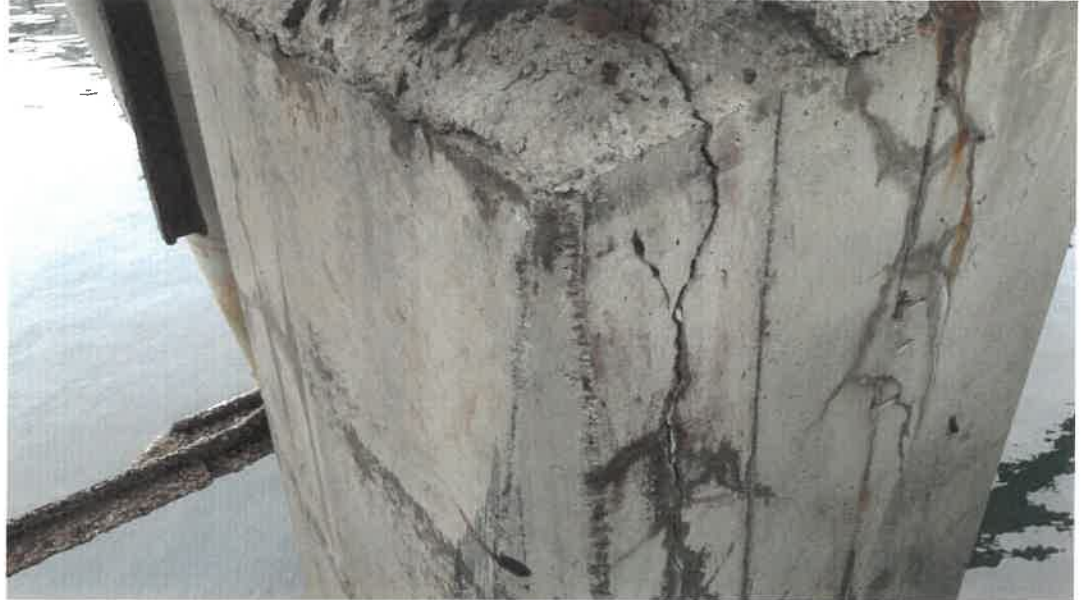
Concrete encasement at Pile RT3-A1 bearing is cracking at top offshore flange.

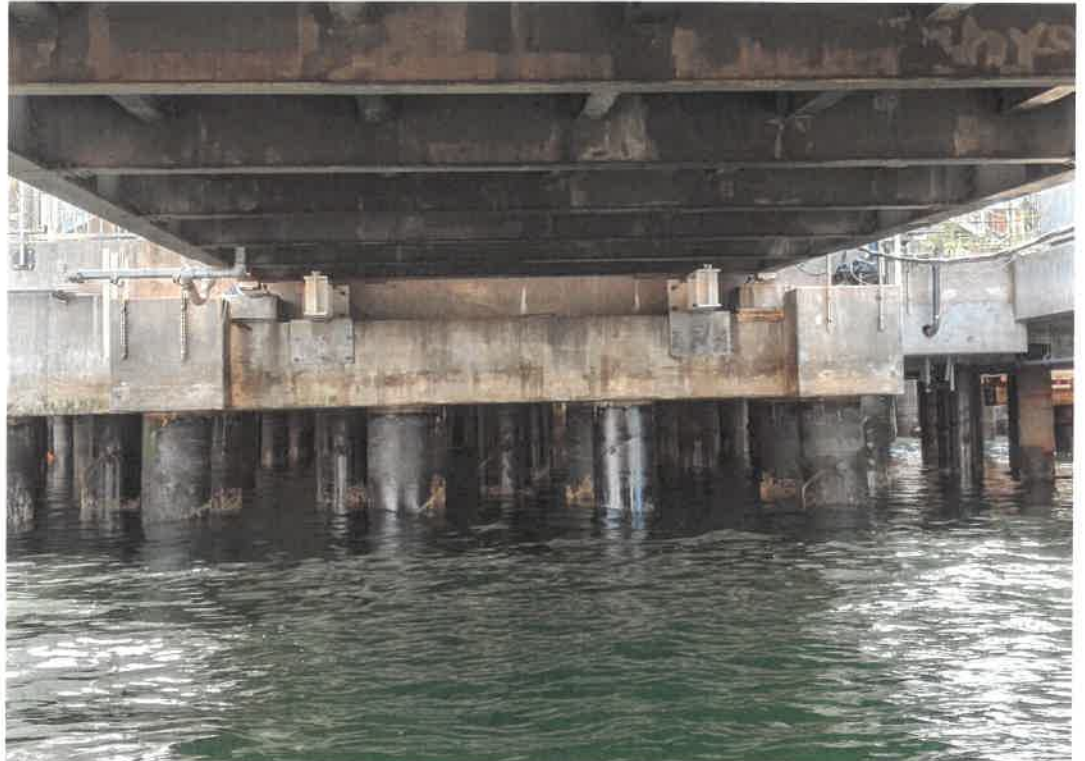
SI-143

Bridge seat piling replaced prior to 2020 inspection (10 new piles) (Photo #143).

New bridge seat in 2020.

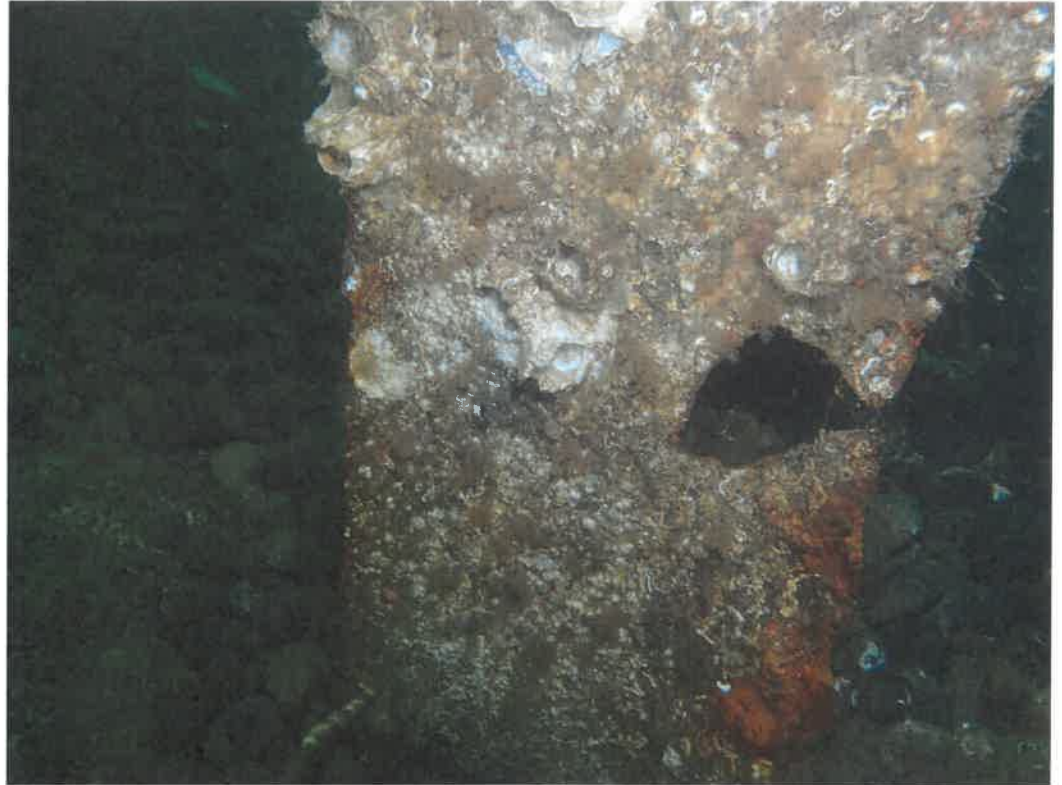
Tower H-piles have up to 5' of steel piles exposed near the mudline. All the exposed steel H-pile below water have corrosion but only 4 piles had measurable section loss. The largest amount of section loss was in the Left Tower Pile 1A which was holed through with heavy knife edging of the flange (Photo UW-1).

4" diameter hole in Left Tower Pile 1A at MDL +1.

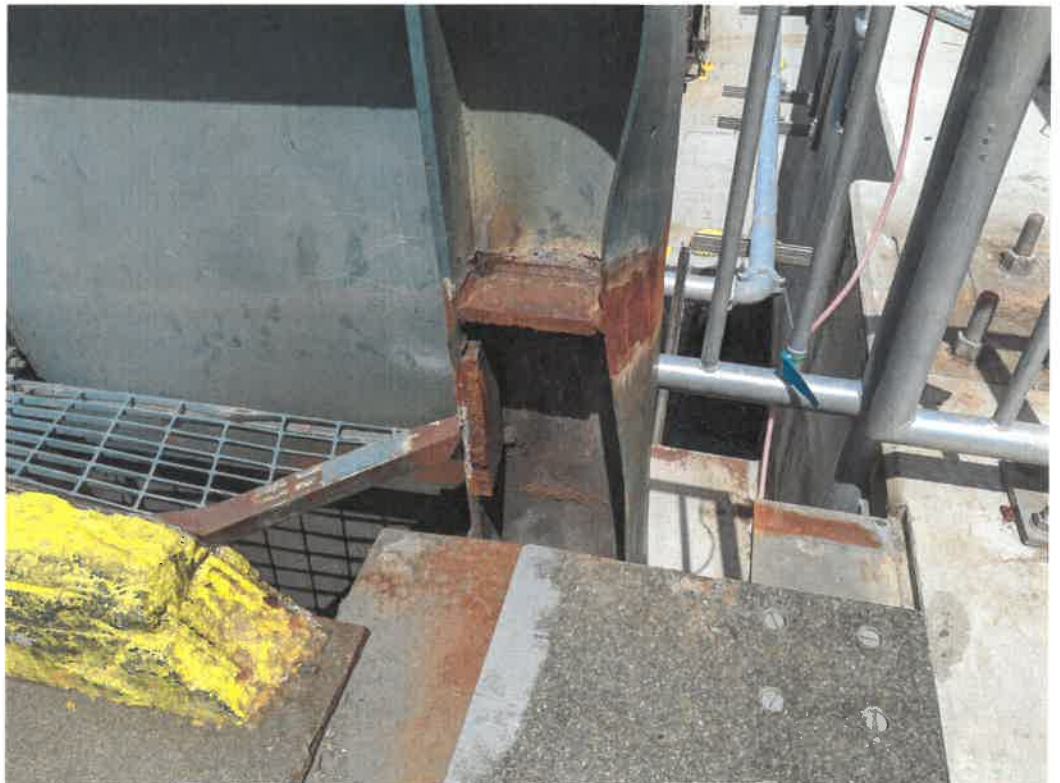
SI-137

Right Girder, shore end with traffic impact. Note the rusty steel plates, added as part of dock construction work.

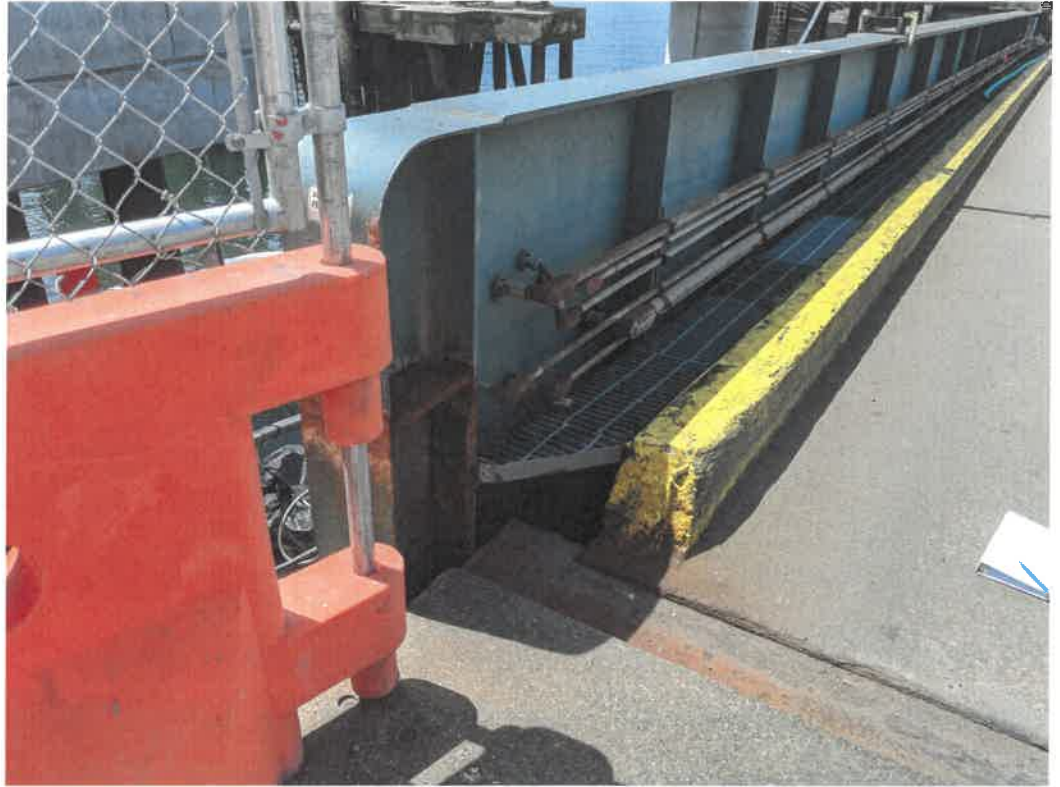
Left Girder, shore end showing construction related retrofit block.

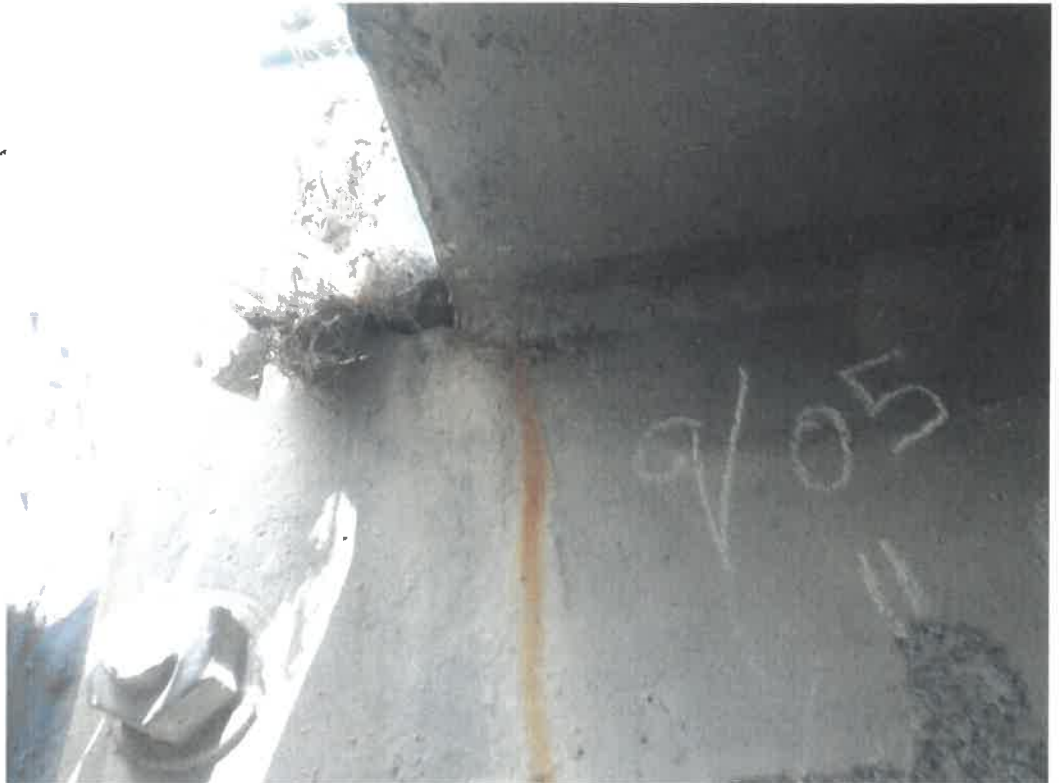
SI-129

Floorbeam 0 right side has a 1-1/2" stepped web crack that is end rusted (Photo #129)(CS3).
 Floorbeam 0 left side has a 2-1/4" stepped web cope crack (Photo #107)(CS3).
 Floorbeam 1 right side has a 1/4" cope crack (Photo #130)(CS3).
 Floorbeam 1 left side has a 1/2" diagonal crack (Photo #89)(CS3).
 Monitor REPAIR #10001.

Floorbeam 0 right end 1-1/2" cope crack.

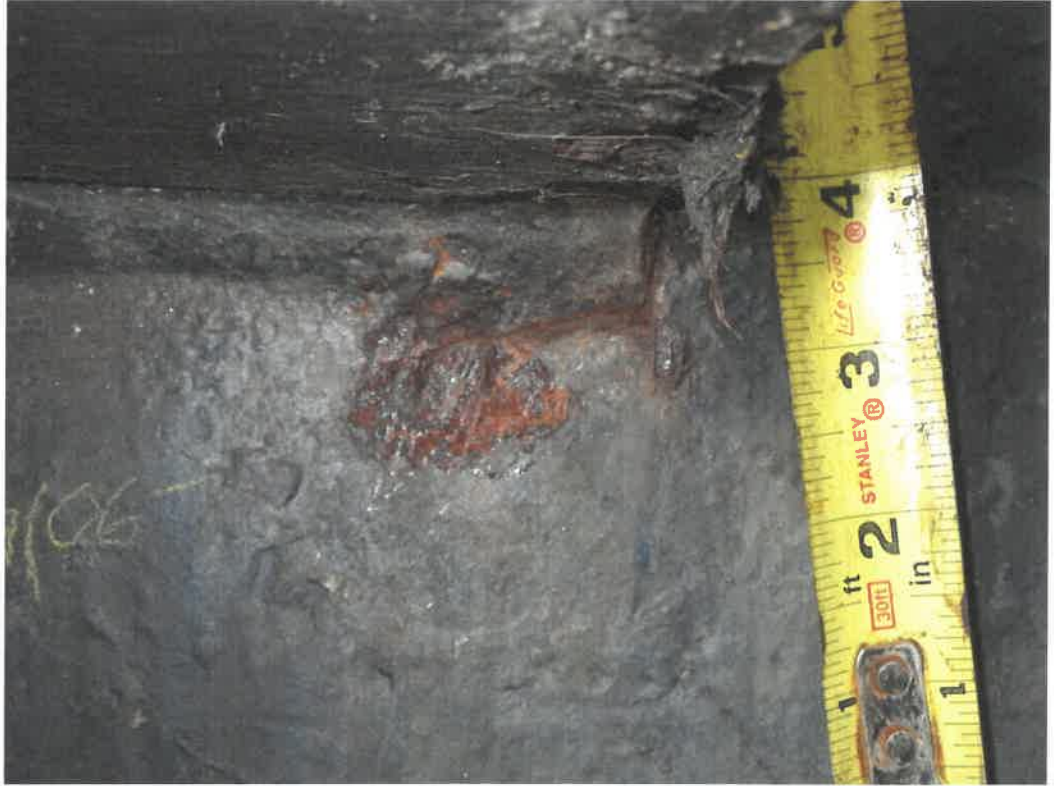
SI-107

8206 Steel Floor Beam
Photo Type: M - Monitor
Orientation: Shore
Date: 6/9/2011
Repairs: 10001
Floorbeam 0 has a 2-1/4" crack on the left end.

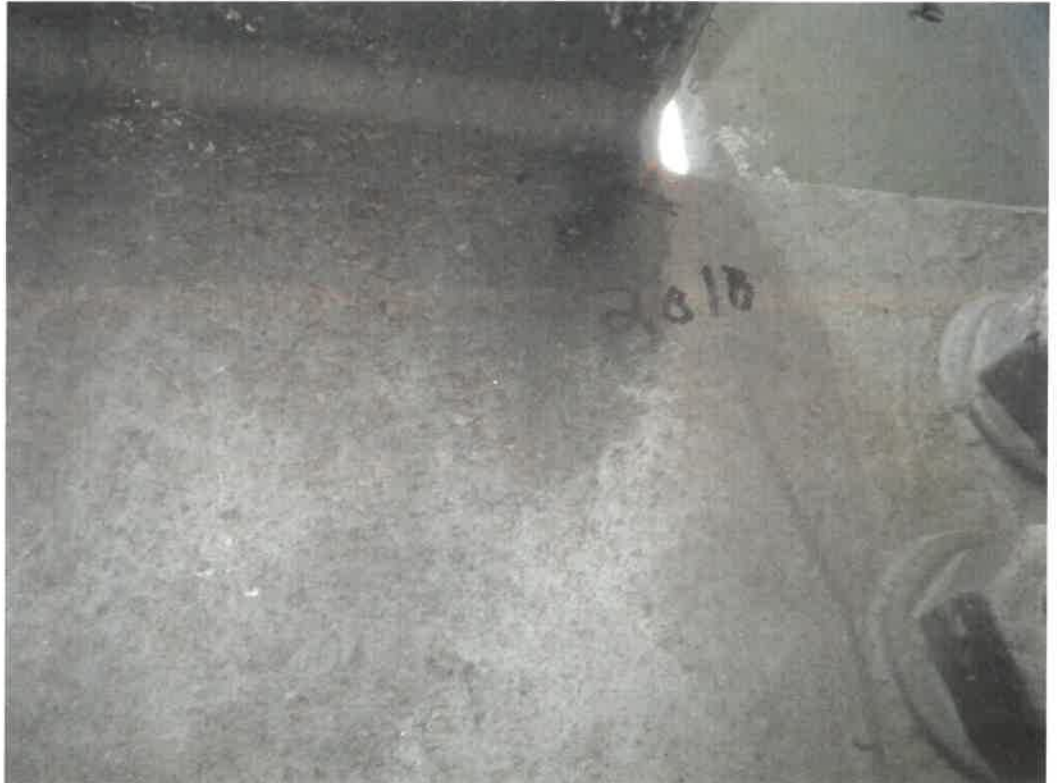
SI-130

8206 Steel Floor Beam
Photo Type: M - Monitor
Orientation: Sea
Date: 6/25/2018
Repairs: 10001
Floorbeam 1 right end has a 1/4" cope crack.

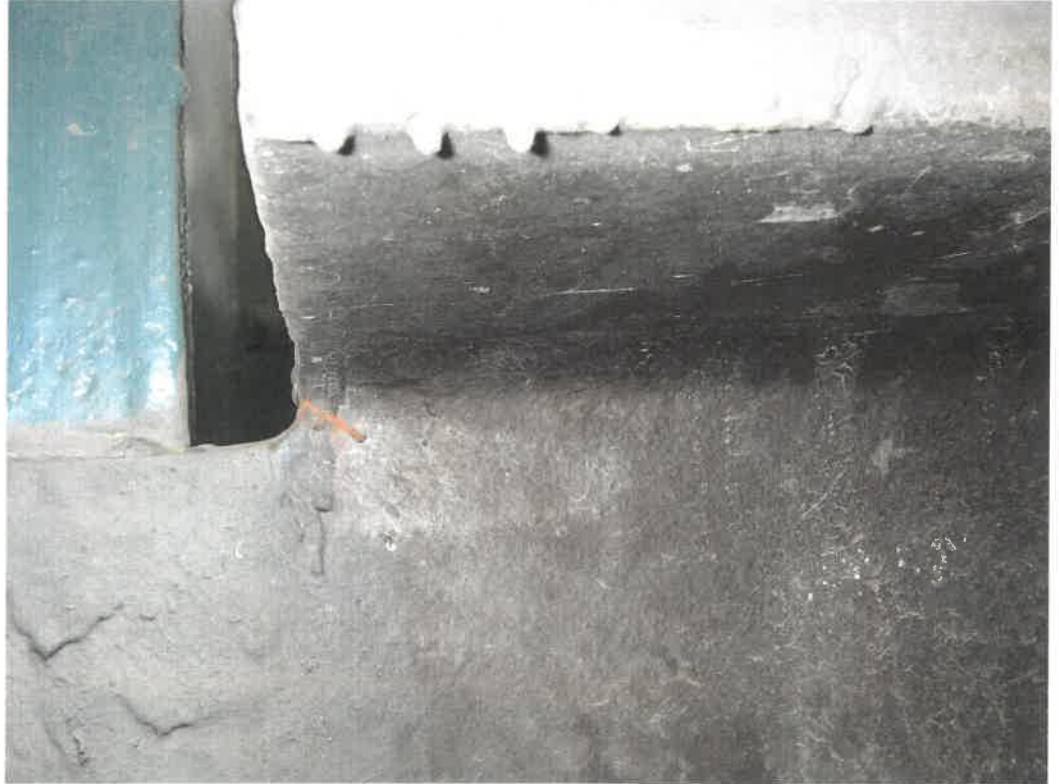
Floorbeam 1 has a 1/2" diagonal crack on the left side.

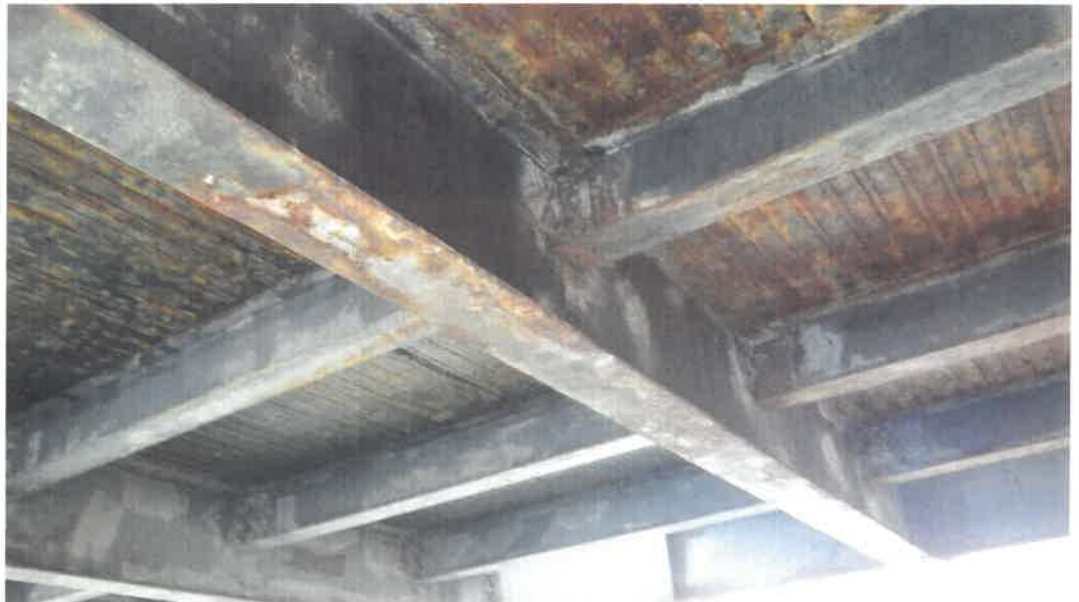
SI-120

The bottom flange of the floorbeams and lateral gussets have section loss in places leaving 10% section loss in localized areas.
 Paint failing with laminar rust starting at Floorbeam 7 off shore side of the bottom flange and increasing offshore (Photo #120)--REPAIR #10002.

Floorbeam 8 failed paint and laminar rust on bottom flange, inshore floorbeams in good condition.

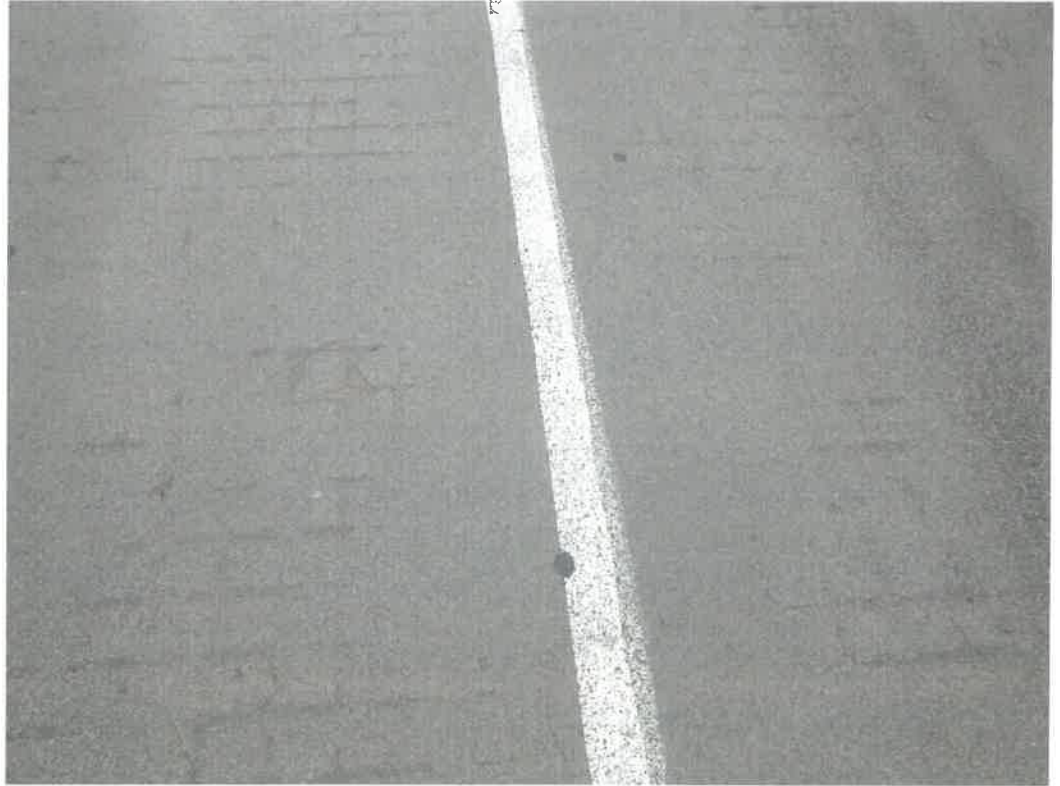
Transfer span has a MMC overlay which has light wear (Photo #117).
 There are 4" diameter shallow depressions in the overlay in the inside wheel line of each lane.

MMC overlay is thinning in wheel lines.

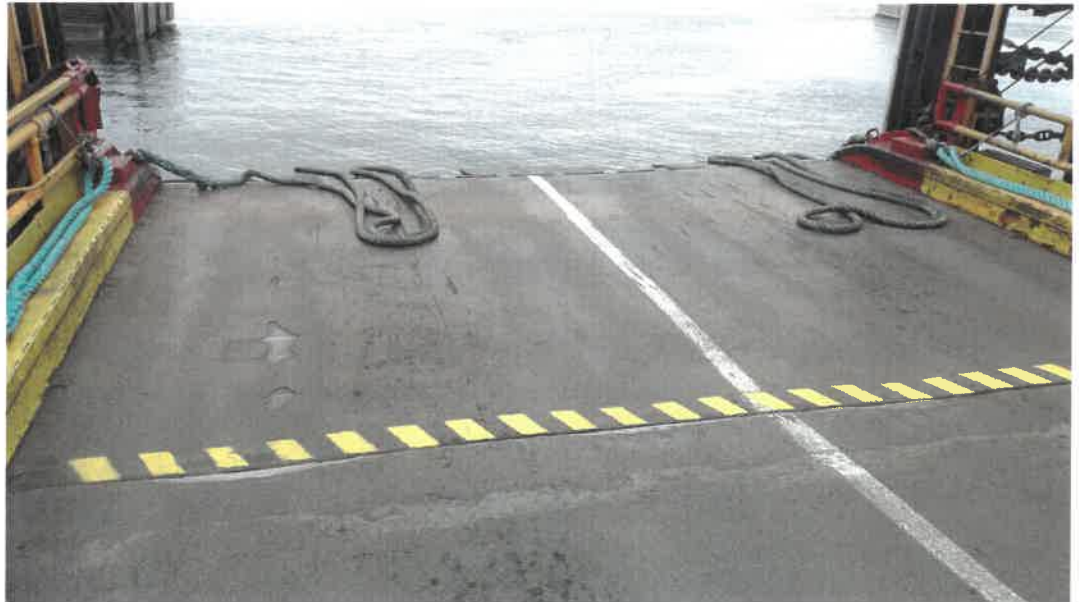
SI-135

Approximately 5 sf. of surfacing is worn off the apron in the wheel lines (Photo #135).

Surfacing worn off in the wheel lines on the apron.

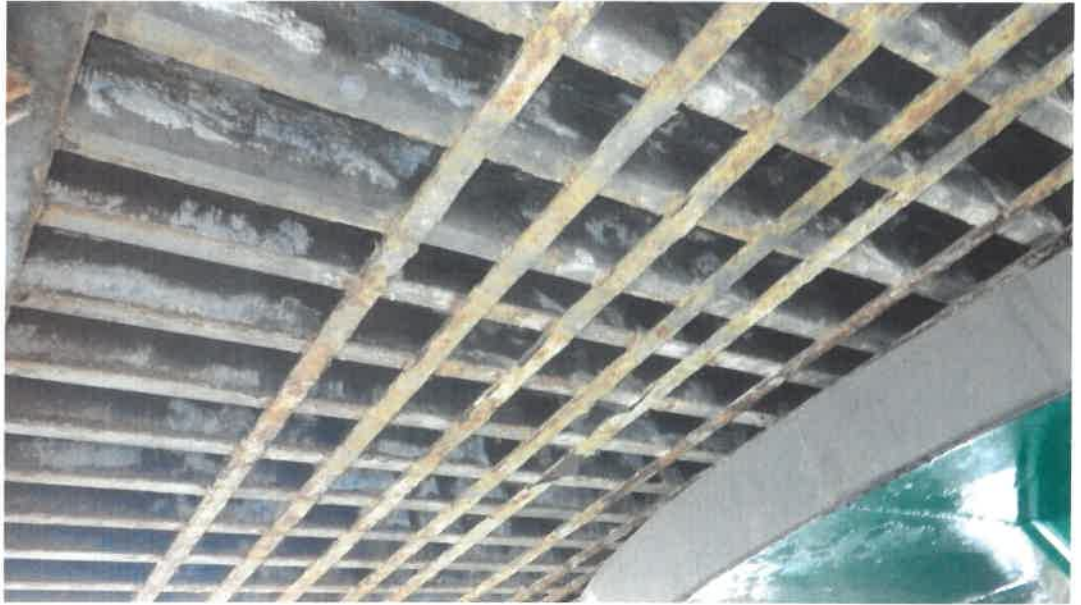
Deteriorated paint on underside of apron.

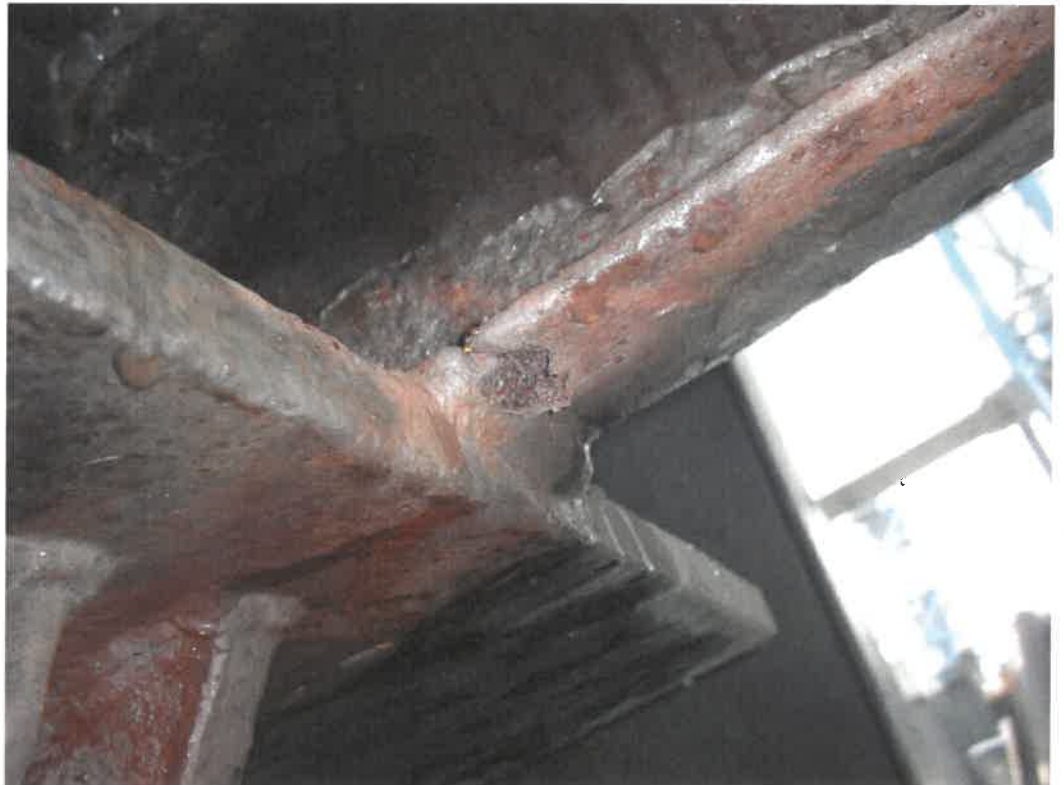
SI-74

Apron channel section cracked and corroding at onshore end.

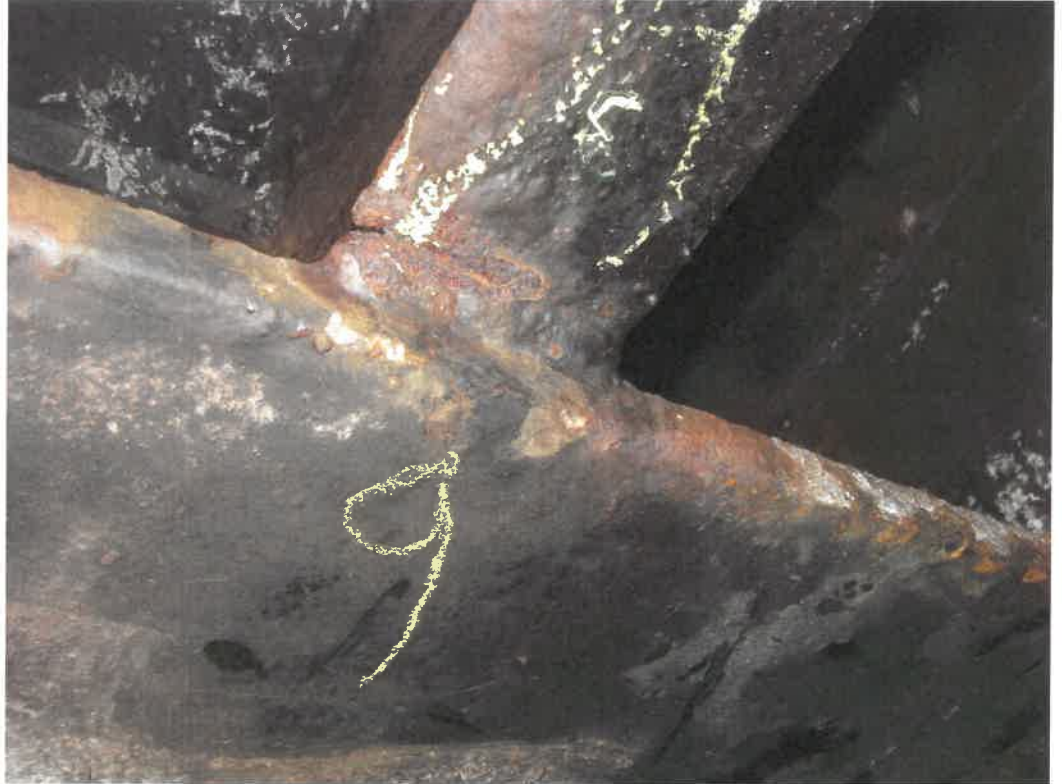
Apron Longitudinal Beam #9 with a heavy groove with 3/4" long crack in the bottom flange.

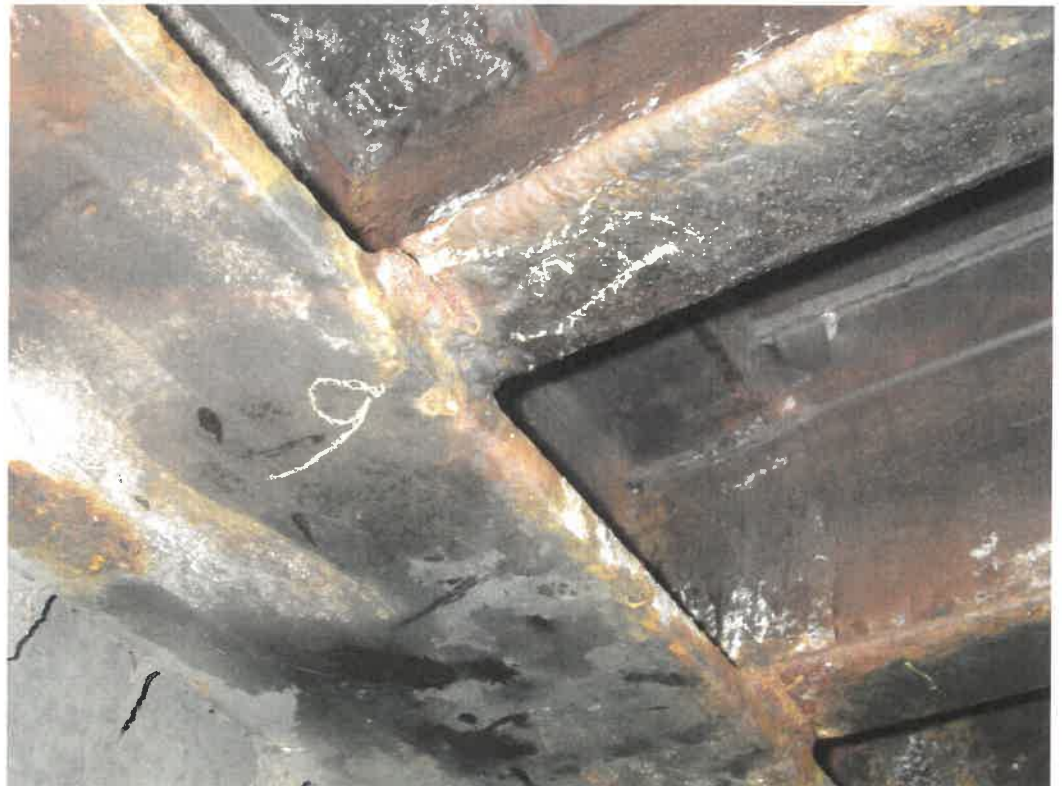
SI-87

Overview photo of Apron Longitudinal Beam 9 where it frames into the shore transverse beam.

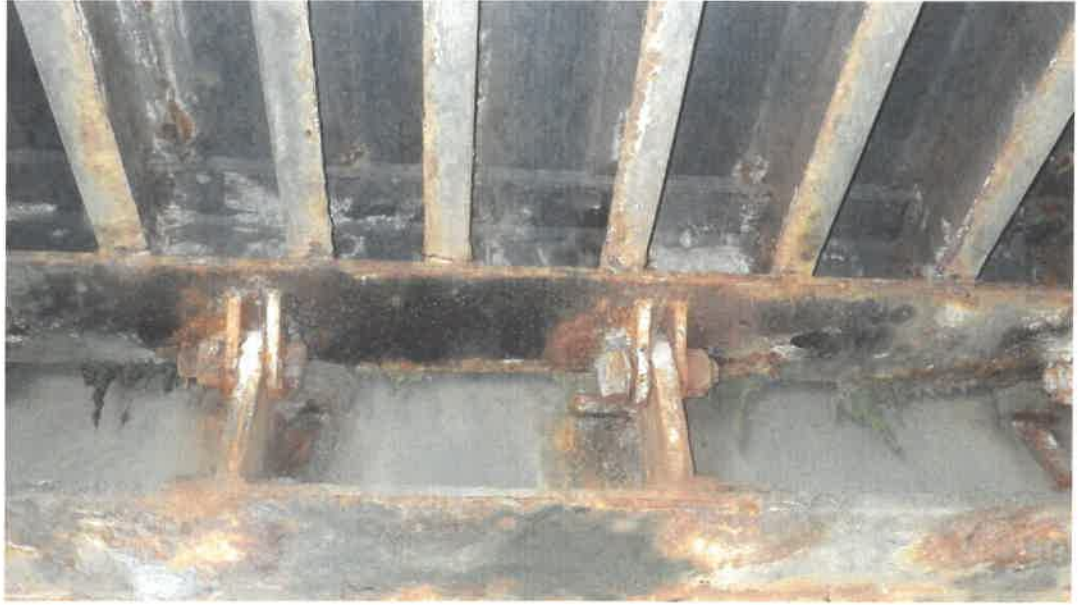
4 of the 8 pins have elongated holes (CS3). Nuts held on with cotter pins (Photo #121).
 Paint has failed with thin layer of laminar rust typical at each hinge--REPAIR #10002.

Apron Hinges, typical condition of failed paint and laminar rust.

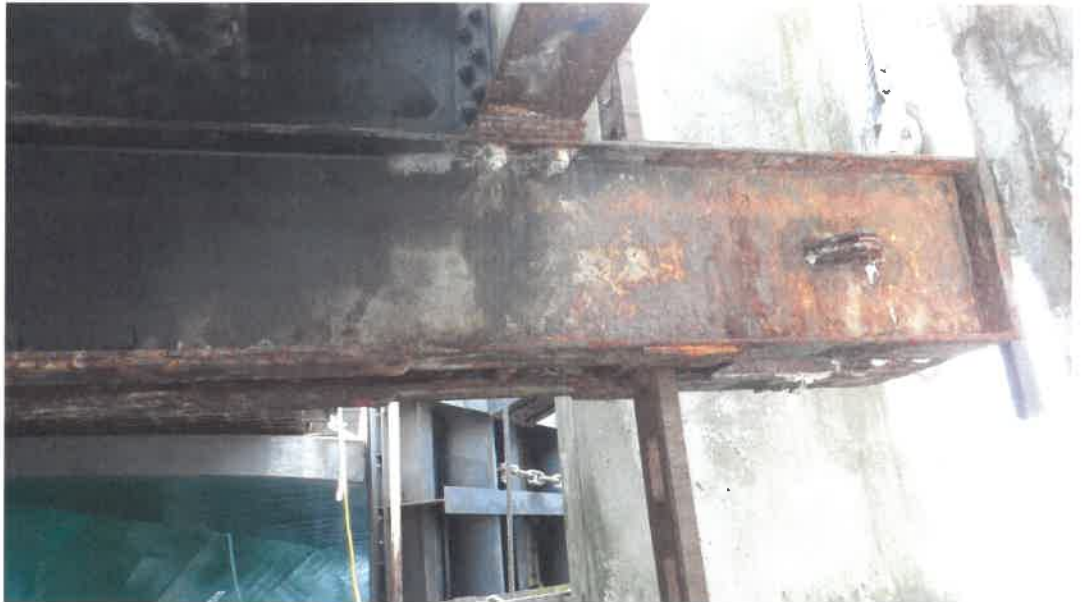
SI-119

Lift beam paint has failed exposing the steel to the salt water, corrosion has increased since the 2014 inspection (Photos #119 and #124)--REPAIR #10002.
 The bottom flange of the lift beam has 10% section loss in bottom flange and webs with heavy laminar rust (Photo #124).
 The bottom cover plate has 4" stitch welds at 1.5 ft. O.C., welds have surface corrosion and slag inclusions (CS3).

Typical end paint condition of lift beam (right side shown).

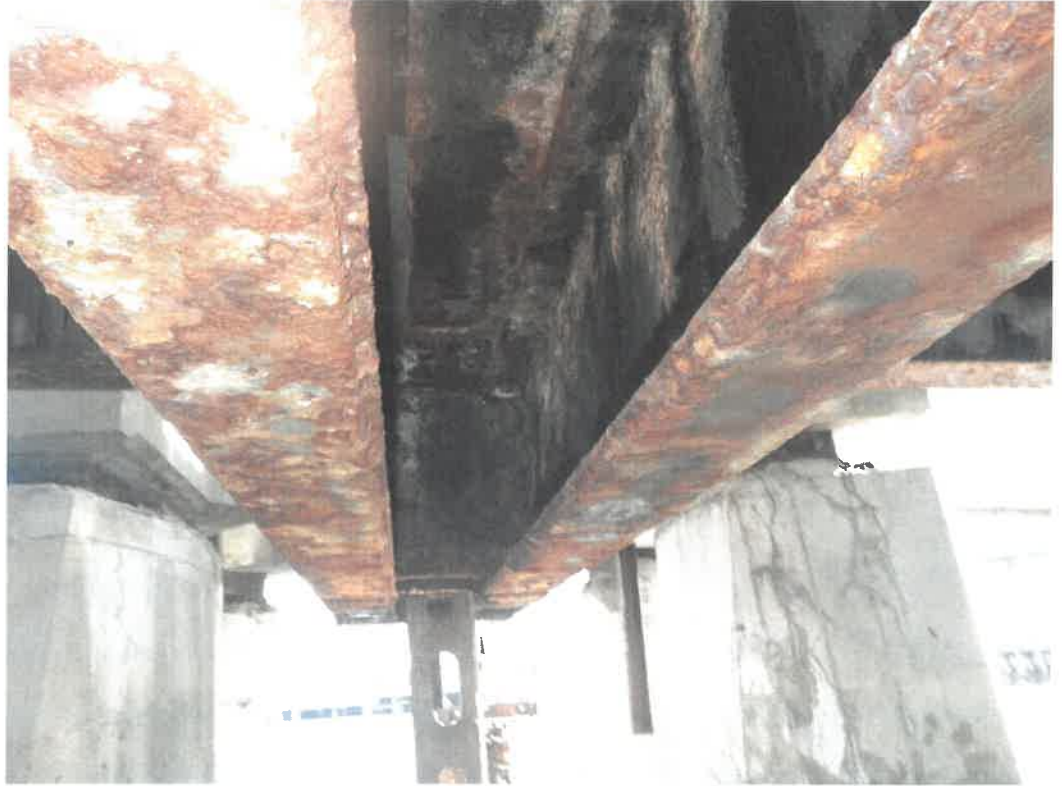
Laminar rust on lift beam. Bottom flanges and webs have 10% section loss.

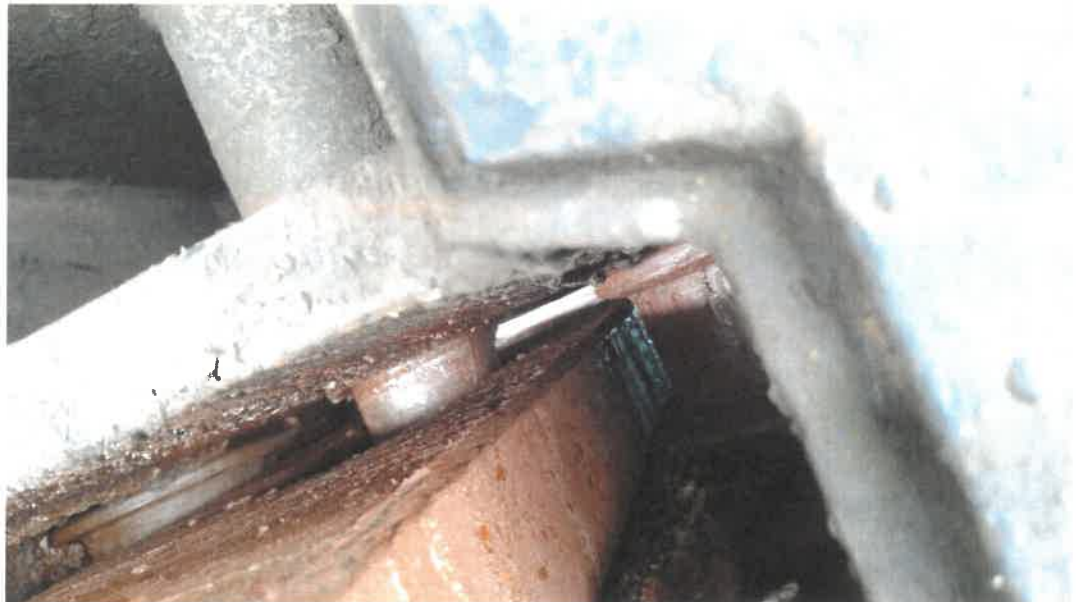
SI-131

Lower pins cannot be UT'd due to design and are visually inspected. Lower pins have wear grooves as noted in the attached file "Seattle Slip 3 FC Workbook" (Photos #131 and #132)(CS3)--REPAIR #10004.

Overview of lower live load pin in hanger bar. Lower side of lower pins has a wear groove from the hanger.

10004	M	B	Replace the lower live load pins, which have wear grooves around 1/4" deep from contact with the live load hangers. DRB 1/30/19. Changed repair to a MONITOR per WSF request. Change to a P1 repair when wear groove reaches 1/2". See attached e-mail dated 1/30/19.	8343	6/25/2018

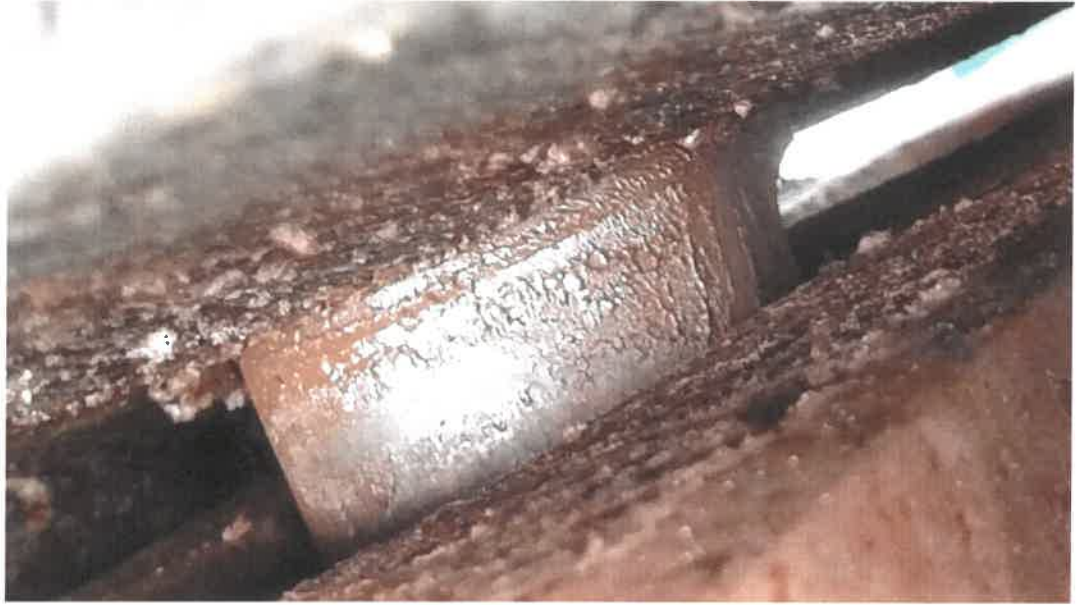
Closeup of lower live load pin showing
wear groove. Typical in each lower pin.

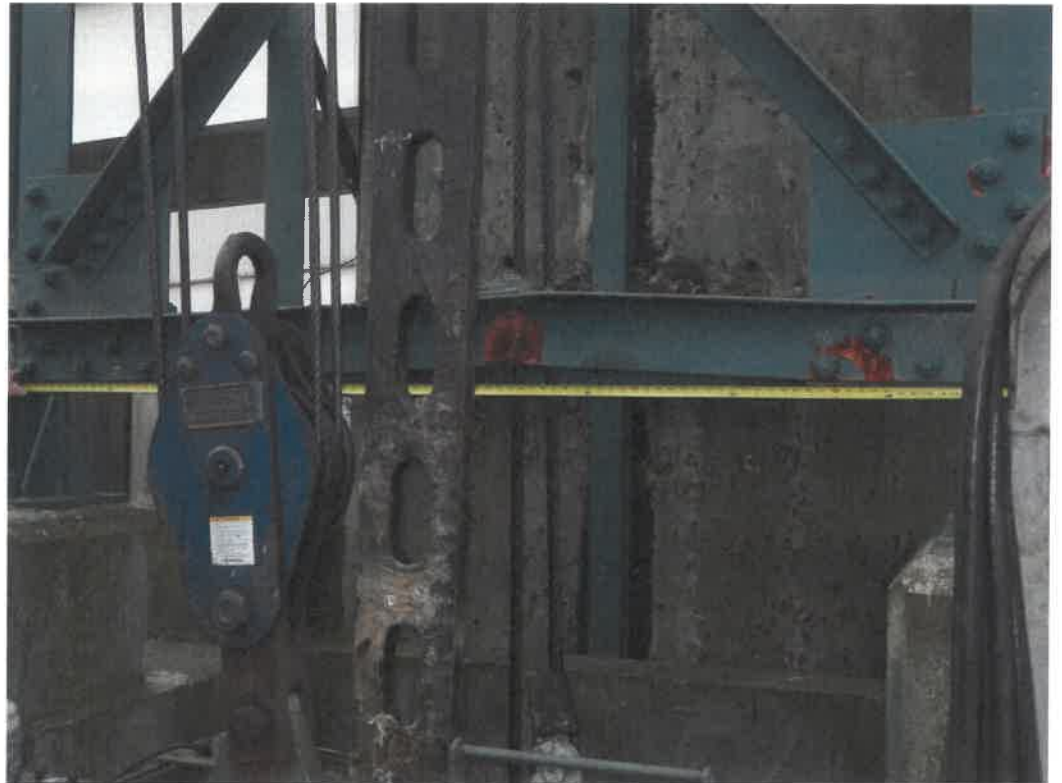
SI-109

Left tower lower strut is bent up 1-3/4" at midpoint and the right tower lower strut is bent up 2-1/2" and buckled at midpoint. Both are bent from the lift beam coming in contact with the tower (Photos #109 and #112)(CS3)--REPAIR #4.

Bent strut on the left tower. Bent up
1=3/4" inch. Bend from raising transfer
span too high and the lift beam impacting
tower brace.

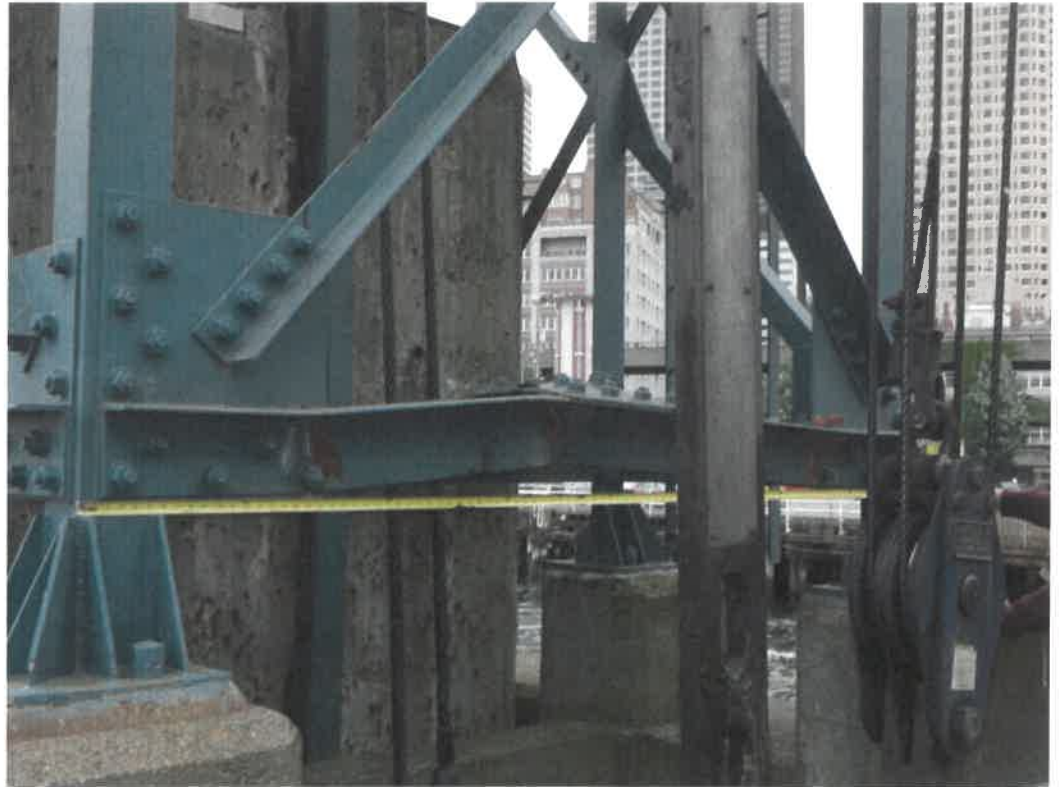
Right tower bent strut 2-1/2" over full width.

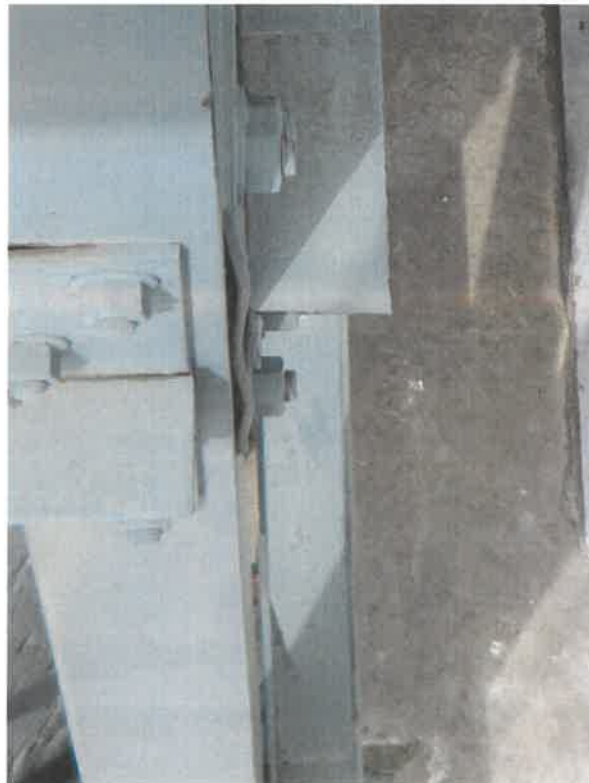
SI-90

Both lift towers have pack rust, 1/4" thick, at the mid height gusset plates (Photos #90 and #91).

Pack rust in tower gusset plates due to lack of stitch bolts.

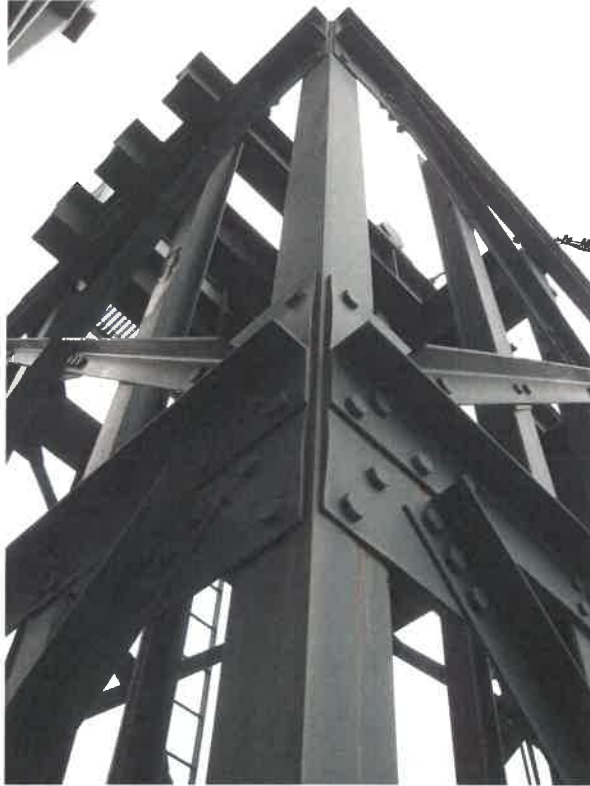
Pack rust in tower gusset plates due to lack of stitch bolts.

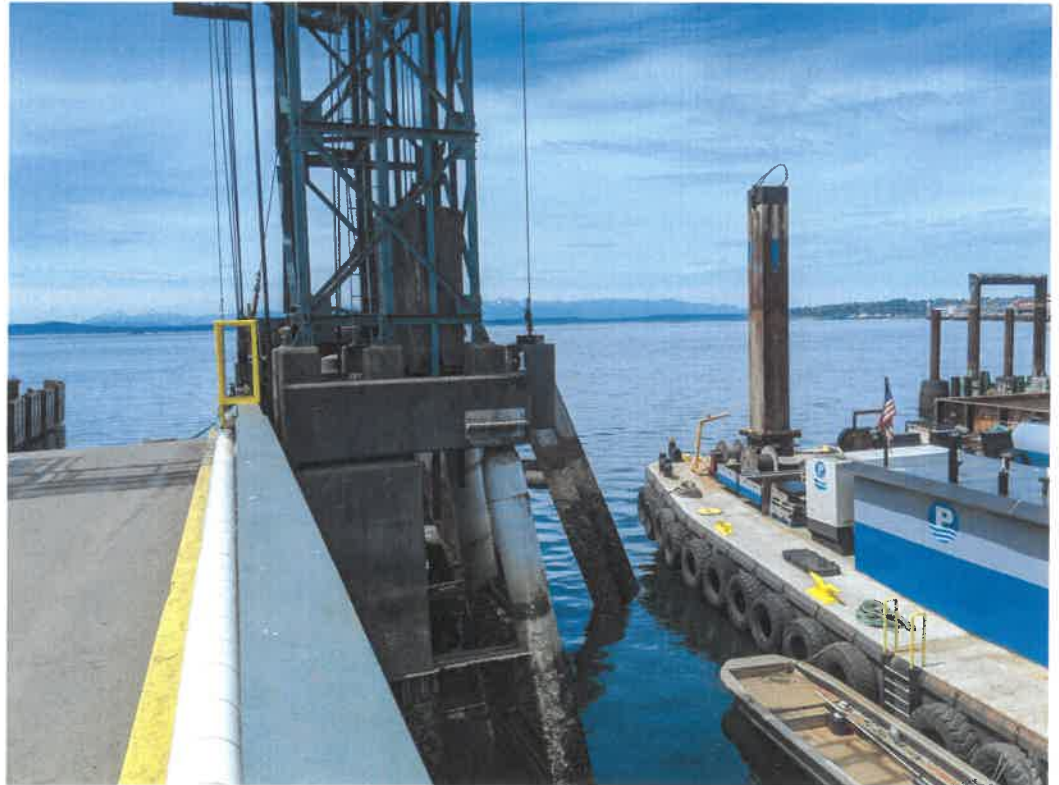
SI-136

Apron counterweights were replaced prior to the 2020 inspection (Photo #136).

Right side counterweights, left side are similar.
